**Flood Control Project Maintenance
Levee Inspections**
LMA District Cover Sheet
Spring 2018 Levee Inspection Results

Reclamation District No. 0536 Egbert

Levee Inspection Report By Mile - Spring 2018

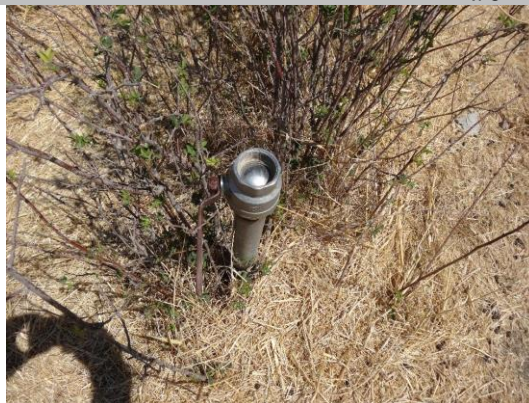
Photo 2 of 3 : UCIP_SP_2018_49314_34788.jpg

FS_ID:49314
DS_ID:24023
EP_NO: N/A
Repair Type: Non-Urgent
Crossing Status: Found
UCIP Comments: 06/01/2016 Could not see flapgate in water. Pipes still in use. No cover over pressure relief valve on WS slope. 08/13/2013:- Field discovered pipe.- Needs more information from the LMA/ DWR Inspector. - Dense vegetation on WS.- Pump feeds both pipes.
FIELD_STRUCT_DESC: 2 of 2: 18-inch steel drainage discharge pipe through the levee, approximately 4 feet below the crown. Pump, called the Buddha Pump, in a pump house on the landside (LS) at the drainage ditch. Pressure breaker on the waterside (WS) slope. Pump and pipes are used by Reclamation District No. 536 (RD0536), per district president David Hearn, but could not identify permit information. Landowner is Dan Hearn per Solano County Assessor's Office (Parcel No. 0042-180-220).
FS Date: 6/1/2016

WS view: pressure breaker/valve on levee slope.

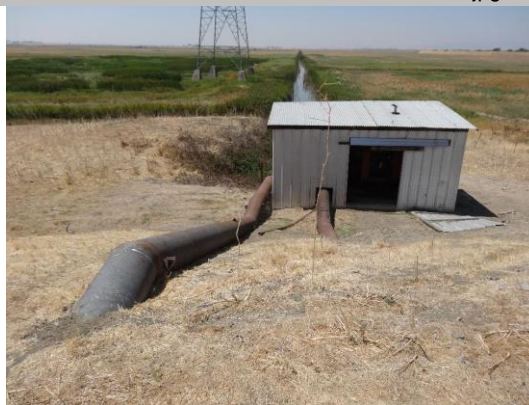
Photo 3 of 3 : UCIP_SP_2018_49314_34787.jpg

WS view: exposed 18" steel pipe (left) and 16" steel pipe (right) on levee slope. Pump house on bank of drainage ditch.

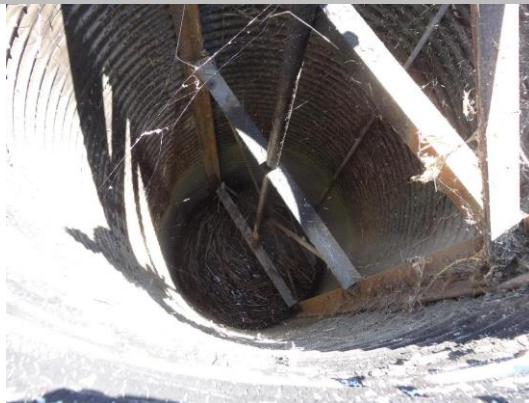
Photo 2 of 3 : UCIP_SP_2018_20503_34567.jpg

Comment Code					
Inspector Comment					
FS_ID:20503 DS_ID:22718 EP_NO: 10116 Repair Type: No Action Needed Crossing Status: Found UCIP Comments: Vortex seen on WS. Water flow seen on LS.Saddle, apron, and headwall not visible. Inlet and outlet pipe-ends are submerged into water. FIELD_STRUCT_DESC: 54-inch corrugated metal gravity drainage pipe through the levee, 30 feet below the crown. Screw gate in a pipe riser on the waterside (WS) slope. Saddle, apron, headwall, two corrugated metal cutoff walls, one No. 101 gate, and one No. 102 gate. (Retention of a 54-inch drainage pipe through the levee, 30 feet below the crown, and a slide gate on the WS slope authorized under Automatic Board Order (ABO) 10116, 1974 - Marion Sanchez Farms). [Additional Reference(s): DWR Levee Log, 1992. USACE Sacramento O&M Manual 106, May 1953, (Station 87+70 ""R""), invert elevation -2 feet]. FS Date: 8/13/2013

WS view: closer view of slide gate in CMP riser on levee slope.

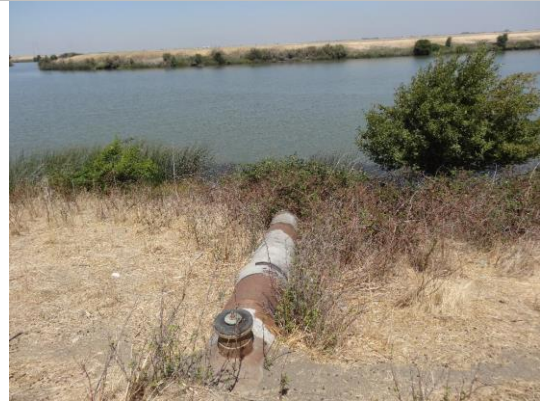
Photo 1 of 3 : UCIP_SP_2018_49317_34579.jpg

FS_ID:49317
DS_ID:22719
EP_NO: 2131
Repair Type: Non-Urgent
Crossing Status: Found
UCIP Comments: 06/01/2016 New pump recently installed. Flapgate not visible though not required under condition of Permit No. 2131. No positive closure device found, which, if missing, is a violation of Condition 8 of Permit No. 2131. Need a name change permit for new owner RD0536. Siphon breaker missing cover.08/13/2013 Pump is missing at the time of inspection. May be taken out for repair.Flappage on waterward end not found/visible as pipe was submerged into water.Pipe itself is a walkway with steel handrail.
FIELD_STRUCT_DESC: 20-inch drainage discharge pipe of an unknown material through the levee, 1.5 feet below the crown. Pump, which was replaced recently, is on a steel platform in the drainage ditch on the landside (LS) toe. Siphon breaker on the waterside (WS) slope. Pipe is exposed on both slopes, but only found on the WS in 2016. Walkway over the pipe on the LS leads to the pump platform. Pipe and pump are now used by Reclamation District No. 536 [RD0536], per district president David Hearn. (Plans for construction of a 20-horsepower drainage pump installation and a 20-inch discharge pipe through the levee authorized under Permit No. 2131, 1955 - California Packing Corporation). [Additional Reference(s): DWR Levee Log, 1992]. FS Date: 6/1/2016

WS view: exposed steel pipe with siphon breaker on levee slope.

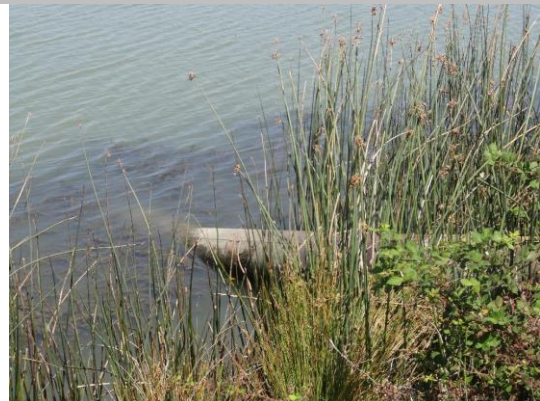
Photo 2 of 3 : UCIP_SP_2018_49317_34578.jpg

WS view: steel pipe submerged into water in the stream.

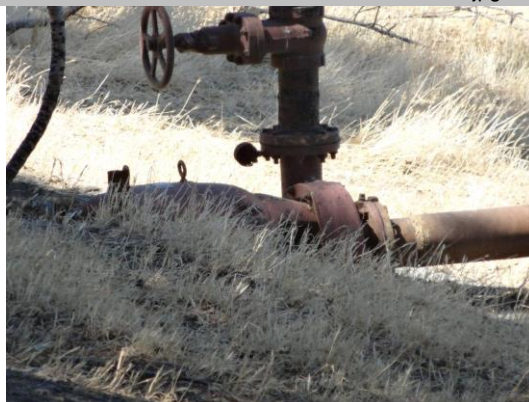
Photo 2 of 2 : UCIP_SP_2018_20543_34622.jpg

LM Start	5.10	Rating **	M	Issue No.	75	
LM End	5.10	Issue Type +	En	Location *		
Category	Supplemental			GPS Latitude/Longitude		
				Start		End
Item	DWR UCIP Field Study			38.245783 °		38.245783 °
				-121.705999 °		-121.705999 °
DWR ID						
Comment Code						
Inspector Comment						
FS_ID:20543 DS_ID:22721 EP_NO: 3873 Repair Type: Non-Urgent Crossing Status: Found UCIP Comments: Pipe seems to be abandoned.Needs proper abandonment. FIELD_STRUCT_DESC: 6-inch irrigation discharge pipe of an unknown material through the levee, 2 feet below the crown. Pump on a concrete base on the waterside (WS) slope. Gate valve on the WS slope. (Plans for installation of a 6-inch pipe through the levee authorized under Permit No. 3873, 1962 - California Packing Corporation). [Additional Reference(s): DWR Levee Log, 1992]. FS Date: 8/13/2013

WS view: closer view of abandoned pipe, pump, and gate valve on levee slope.

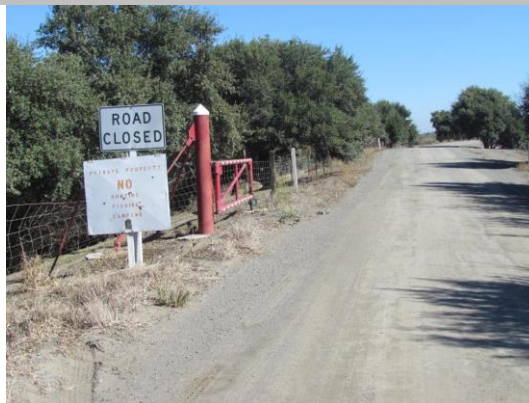
Photo 1 of 2 : SP_2018_RD0536_208_11_20180305_00001.jpg

LM Start	5.34	Rating **	U	Issue No.	11 (cont)
LM End	5.34	Issue Type +	En	Location *	CR

RD 536 Unit 1 levee mile 5.34 waterside shoulder. No change. 4-17.

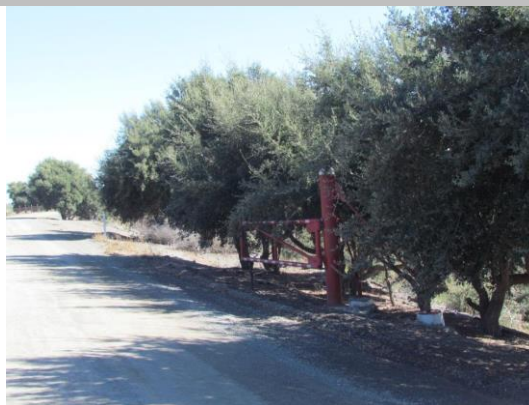
Photo 2 of 2 : SP_2018_RD0536_208_11_20180305_00002.jpg

This gate rest and gate on the landside of the levee shoulder.

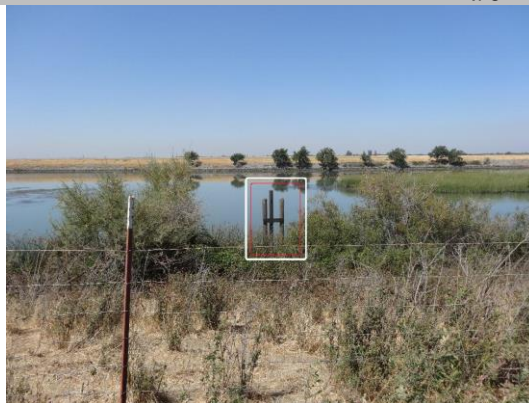
Photo 1 of 3 : UCIP_SP_2018_20563_34646.jpg

Comment Code					
Inspector Comment					
FS_ID:20563 DS_ID:22722 EP_NO: 7208 Repair Type: Non-Urgent Crossing Status: Found UCIP Comments: - siphon breaker needs cover/protection.- service pole on landside of the levee. FIELD_STRUCT_DESC: 30-inch steel drainage discharge pipe through the levee, 5.7 feet below the crown. Pump in a piling structure in a drainage ditch on the landside (LS). Siphon breaker on the waterside (WS) shoulder. (Plans to install a drainage pumping plant and 35 feet of 30-inch pipe through the levee authorized under Permit No. 7208, 1970 - Reclamation District No. 536 [RD0536]). [Additional Reference(s): DWR Levee Log, 1992]. FS Date: 8/13/2013

WS view: wooden & steel piles on the slough. Probably the supports are for pipe and flap gate. Not accessible due to fence.

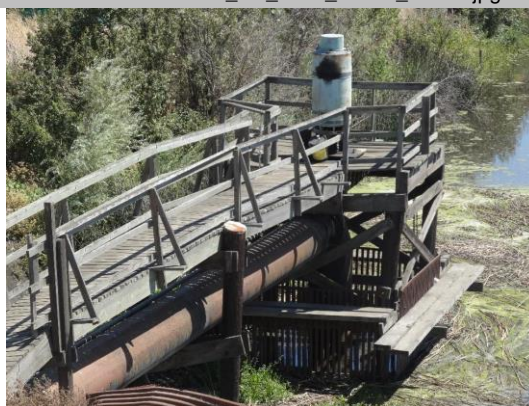
Photo 3 of 3 : UCIP_SP_2018_20563_34644.jpg

Comment Code						
Inspector Comment						
FS_ID:20563 DS_ID:22722 EP_NO: 7208 Repair Type: Non-Urgent Crossing Status: Found UCIP Comments: - siphon breaker needs cover/protection.- service pole on landside of the levee. FIELD_STRUCT_DESC: 30-inch steel drainage discharge pipe through the levee, 5.7 feet below the crown. Pump in a piling structure in a drainage ditch on the landside (LS). Siphon breaker on the waterside (WS) shoulder. (Plans to install a drainage pumping plant and 35 feet of 30-inch pipe through the levee authorized under Permit No. 7208, 1970 - Reclamation District No. 536 [RD0536]). [Additional Reference(s): DWR Levee Log, 1992]. FS Date: 8/13/2013

LS view: pipe under the wooden walkway and pump on wooden platform in drain ditch.

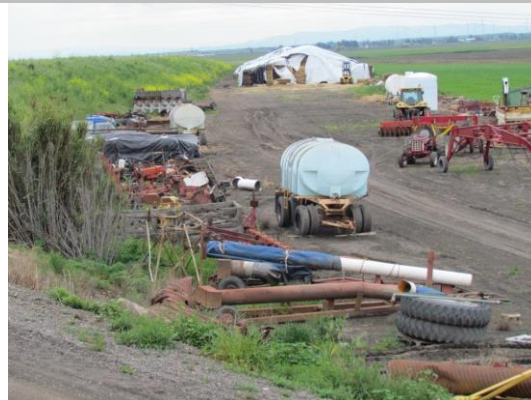
Photo 1 of 1 : SP_2018_RD0536_209_5_20180305_00001.jpg

LM Start	0.09	Rating **	U	Issue No.	5
LM End	0.13	Issue Type +	En	Location *	LS
Category	Earthen Levee			GPS Latitude/Longitude	
				Start	End
Item	Encroachments			38.244240 °	38.243709 °
				-121.696830 °	-121.696934 °
DWR ID	DWR_RD0536_02_s_2012_5				
Comment Code					
EQ : Equipment					
Inspector Comment					
Remove the equipment from the landside easement levee miles 0.09-0.13.

RD 536 Unit 2 levee mile 0.09 landside toe.

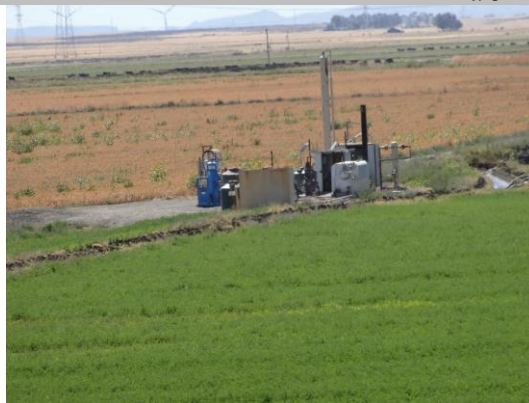
Photo 3 of 3 : UCIP_SP_2018_20664_34744.jpg

LM Start	1.47	Rating **	M	Issue No.	22 (cont)	
LM End	1.47	Issue Type +	En	Location *		
Category	Supplemental			GPS Latitude/Longitude		
				Start	End	
Item	DWR UCIP Field Study			38.224423 °	38.224423 °	
				-121.697049 °	-121.697049 °	
DWR ID						
Comment Code						
Inspector Comment						
FS_ID:20664 DS_ID:22732 EP_NO: 17829 Repair Type: Non-Urgent Crossing Status: Indicator Found UCIP Comments: Indicator is found only on WS. The indicator is different than standard indicator. Needs more info from LMA/DWR Inspector. FIELD_STRUCT_DESC: 3.5-inch welded steel natural gas pipeline under the levee, 44 feet below the crown. (Plans to install a 3.5-inch welded steel natural gas pipeline bored under the levee authorized under Permit No. 17829, 2004 - Towne Exploration Company). FS Date: 8/13/2013

WS view: natural gas extraction plant near levee on the field.

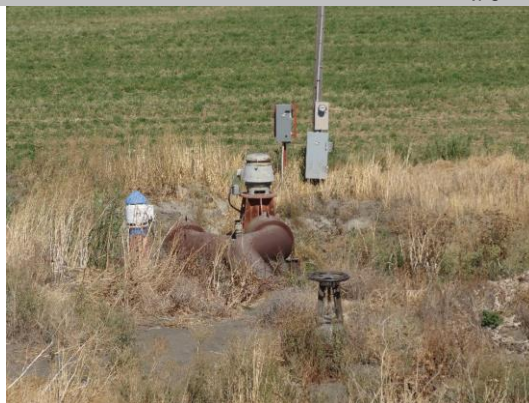
Photo 1 of 2 : UCIP_SP_2018_20647_34731.jpg

LM Start	2.50	Rating **	M	Issue No.	23
LM End	2.50	Issue Type +	En	Location *	
Category	Supplemental			GPS Latitude/Longitude	
				Start	End
Item	DWR UCIP Field Study			38.210063 °	38.210063 °
				-121.691768 °	-121.691768 °
DWR ID					
Comment Code					
Inspector Comment					
FS_ID:20647 DS_ID:24025 EP_NO: N/A Repair Type: Non-Urgent Crossing Status: Found UCIP Comments: Needs more info from LMA/DWR Inspector. Pump and pipe looks new. FIELD_STRUCT_DESC: 12-inch steel irrigation discharge pipe with vertical pump on the drainage ditch. No other details available. This crossing was field discovered. FS Date: 8/13/2013

WS view: overview of pipe and pump (left). Big pump and appurtenances (right) for 24" steel pipe.

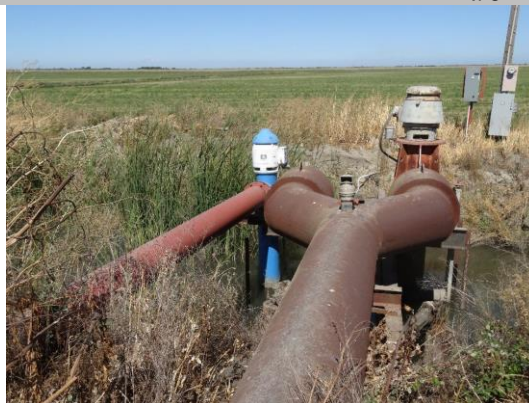
Photo 2 of 2 : UCIP_SP_2018_20647_34730.jpg

LM Start	2.50	Rating **	M	Issue No.	23 (cont)	
LM End	2.50	Issue Type +	En	Location *		
Category	Supplemental			GPS Latitude/Longitude		
				Start	End	
Item	DWR UCIP Field Study			38.210063 °	38.210063 °	
				-121.691768 °	-121.691768 °	
DWR ID						
Comment Code						
Inspector Comment						
FS_ID:20647						
DS_ID:24025						
EP_NO: N/A						
Repair Type: Non-Urgent						
Crossing Status: Found						
UCIP Comments: Needs more info from LMA/DWR Inspector. Pump and pipe looks new.						
FIELD_STRUCT_DESC: 12-inch steel irrigation discharge pipe with vertical pump on the drainage ditch. No other details available. This crossing was field discovered.						
FS Date: 8/13/2013

WS view: closer view of pipe and pump (left). Big pump and appurtenances (right) for 24" steel pipe.

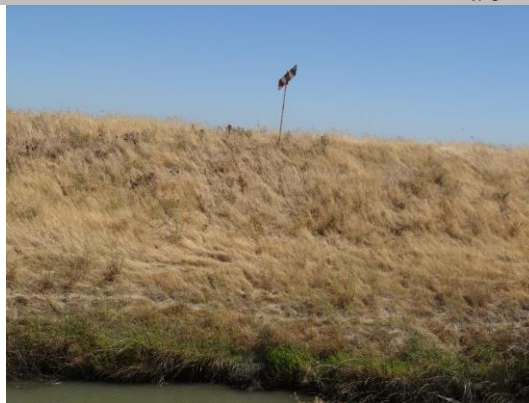
Photo 1 of 2 : UCIP_SP_2018_41845_34765.jpg

LM Start	4.14	Rating **	M	Issue No.	24
LM End	4.14	Issue Type +	En	Location *	
Category	Supplemental			GPS Latitude/Longitude	
				Start	End
Item	DWR UCIP Field Study			38.195875 °	38.195875 °
				-121.695177 °	-121.695177 °
DWR ID					
Comment Code					
Inspector Comment					
FS_ID:41845 DS_ID:22731 EP_NO: 1217 Repair Type: Non-Urgent Crossing Status: Indicator Found UCIP Comments: Gasline needs markers on both slopes. Existing markers in disrepair. FIELD_STRUCT_DESC: 8.625-inch natural gas pipeline of an unknown material through the levee, at an unknown depth. (Plans for installing an 8.625-inch natural gas pipeline crossing authorized under Permit No. 1217, 1947 - Pacific Gas and Electric Company [PG&E]). [Additional Reference(s): DWR Levee Log, 1992]. FS Date: 8/13/2013

WS view: gasline indicator across the channel.

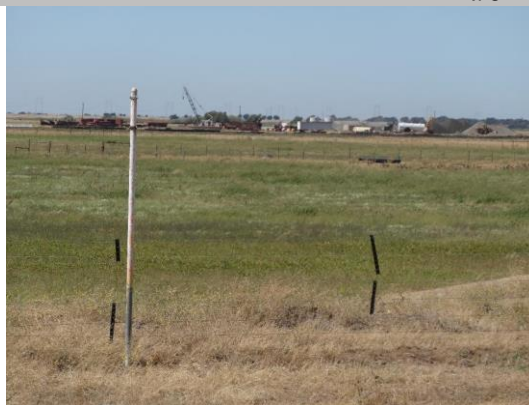
Photo 2 of 2 : UCIP_SP_2018_41845_34764.jpg

LS view: gasline indicator on levee toe.

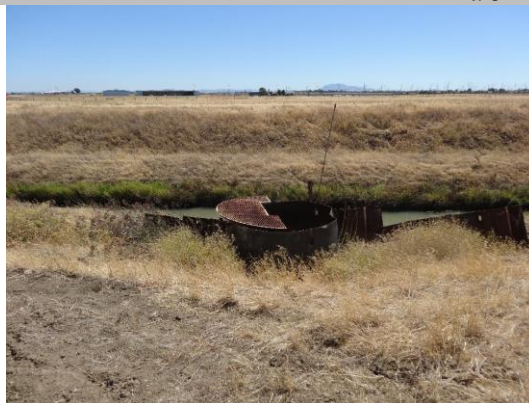
Photo 1 of 3 : UCIP_SP_2018_46813_34768.jpg

LM Start	4.36	Rating **	M	Issue No.	25	
LM End	4.36	Issue Type +	En	Location *		
Category	Supplemental			GPS Latitude/Longitude		
				Start		End
Item	DWR UCIP Field Study			38.196429 °		38.196429 °
				-121.698962 °		-121.698962 °
DWR ID						
Comment Code						
Inspector Comment						
FS_ID:46813 DS_ID:22735 EP_NO: N/A Repair Type: Non-Urgent Crossing Status: Found UCIP Comments: Recommend owner contact CVFPB to provide updated owner info and obtain necessary permit for this crossing. FIELD_STRUCT_DESC: 18-inch steel drainage pipe through the levee, at an unknown depth. Steel standpipe on each side of the levee. Temporary canvas about 2 inches below the crown. Per 2015 Inspection Report provided by Herman Phillips, a diesel motor was found on the waterside (WS), and the owner is Mr. Page Baldwin. This crossing was field discovered. FS Date: 8/13/2013

WS view: steel standpipe on levee slope.

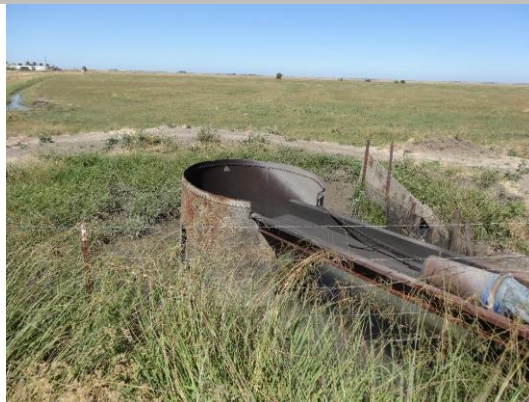
Photo 2 of 3 : UCIP_SP_2018_46813_34767.jpg

LS view: steel standpipe on levee slope.

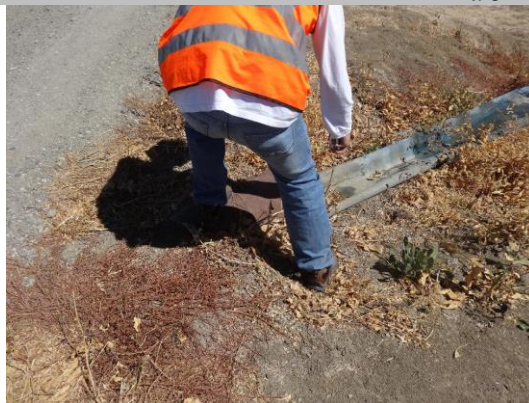
Photo 3 of 3 : UCIP_SP_2018_46813_34766.jpg

LM Start	4.36	Rating **	M	Issue No.	25 (cont)	
LM End	4.36	Issue Type +	En	Location *		
Category	Supplemental			GPS Latitude/Longitude		
				Start		End
Item	DWR UCIP Field Study			38.196429 °		38.196429 °
				-121.698962 °		-121.698962 °
DWR ID						
Comment Code						
Inspector Comment						
FS_ID:46813 DS_ID:22735 EP_NO: N/A Repair Type: Non-Urgent Crossing Status: Found UCIP Comments: Recommend owner contact CVFPB to provide updated owner info and obtain necessary permit for this crossing. FIELD_STRUCT_DESC: 18-inch steel drainage pipe through the levee, at an unknown depth. Steel standpipe on each side of the levee. Temporary canvas about 2 inches below the crown. Per 2015 Inspection Report provided by Herman Phillips, a diesel motor was found on the waterside (WS), and the owner is Mr. Page Baldwin. This crossing was field discovered. FS Date: 8/13/2013

WS view: steel pipe on levee shoulder at 2-inch below the crown.
